# PAS128: Blackwall Reach

## The full monty

John Robinson, Managing Director, Subscan Technology

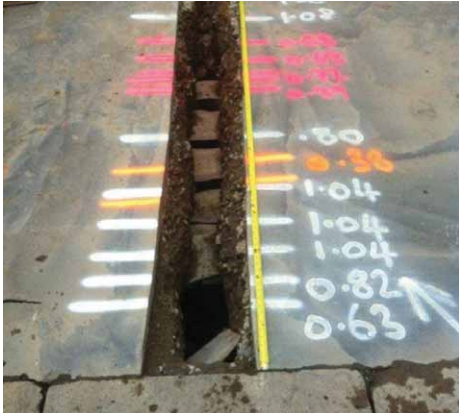
The excavations at Blackwall Reach used a combination of slit trenches and spot excavations to verify critical utility locations using PAS128 survey type A.

Methods for verification can vary depending on the critical point in question. The excavations at Blackwall Reach were a combination of slit trenches, up to 15m in length and spot excavations. In accordance with PAS128, each excavation was surveyed, photographed, collated with cross sectional detail and then reinstated to local authority highway standards over a number of day and night shifts.

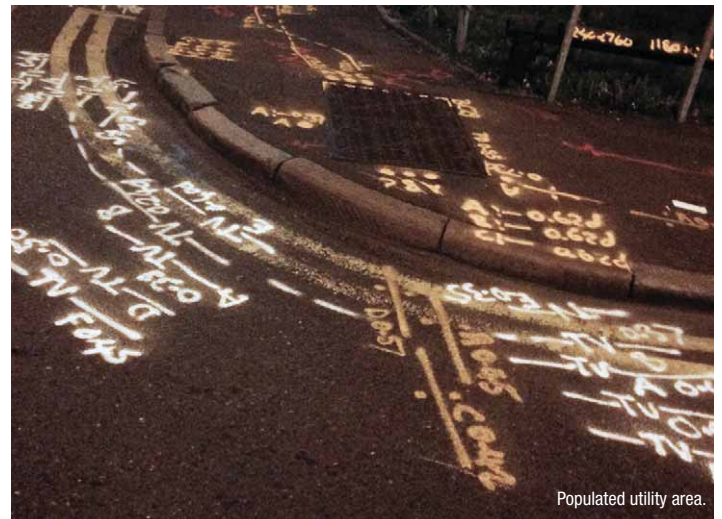
Populated utility area.
